GeoKrete®

Geopolymer Mortar

For raw, storm and wastewater infrastructure rehabilitation.
 Manholes | Tunnels | Culverts | Pipe | Wet Wells | And More...

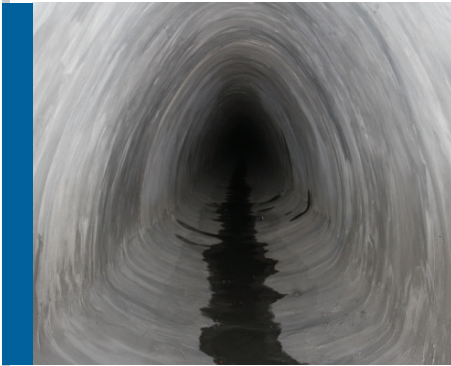
39M DEEP MANHOLE/106M EGG-SHAPED CULVERT REHABILITATION

A 39m deep brick manhole constructed in 1912, along with a 106m of 1980mm x 1675mm brick culvert built in 1915, had reached the end of their useful lives and were in a state of imminent failure.

- Shear depth of the manhole presented challenges. A specially equipped man lift was used to lower crew into manhole.
- 15 large baffles originally built into the manhole structure had to be removed and the voids repaired.
- The culvert outfall was at the base of a steep slope with 60° incline; made access difficult.

The Quadex Lining System® featuring GeoKrete geopolymer. Installation thickness optimized applying varying thicknesses ranging from 25mm to 76mm to provide a fully structural renewal and eliminate I & I.

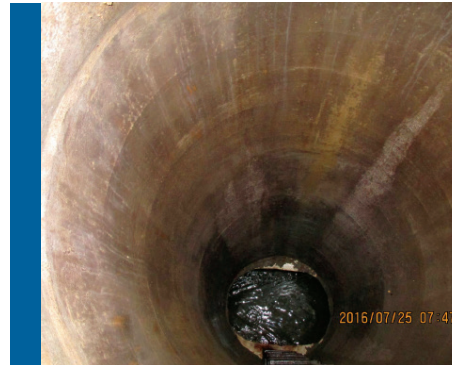
10-YEAR FOLLOW-UP ON GEOKRETE LINED MANHOLES

15 manholes located in Northern Wisconsin, previously coated with a polyurea, were already failing after one year. Extensive flaking and peeling was present indicating a complete failure was imminent.

Quadex® GeoKrete geopolymer was specified to correct the problem and applied with the spinMASTER® system to ensure a consistent lining from top to bottom. A trowel was then used to smooth-out the finish. Since GeoKrete has a quick cure time, the manholes did not have to be taken out of service.

In 2016 the manholes were re-inspected. There were no signs of failure or degradation.

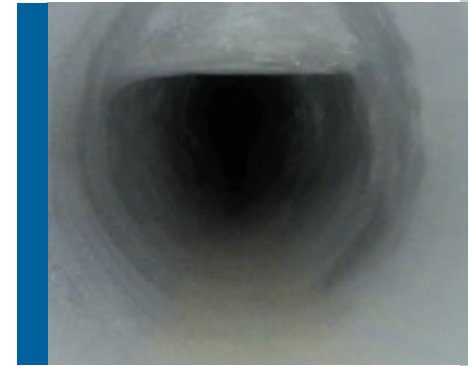
BRICK SEWER REHABILITATION IN FRONT OF BOSTON GENERAL HOSPITAL

A section of an old sewer was odd shaped, contained obstructions and could not be CIPP lined. Since it was located near the hospital entrance a trenchless solution was the only option.

The Quadex Lining System, featuring GeoKrete, was used to reline and structurally restore 492m of 1370mm x 914mm brick sewer. It was spray-applied to the odd-shaped sewer and was able to cover the obstructions as well.

GeoKrete Geopolymer liner is still in the same condition as the day it was installed.
